GENESIS SOLAR WIND COLLECTOR CLEANING ASSESSMENT: 60366 SAMPLE CASE STUDY.

Introduction: In order to recognize, localize, characterize and remove particle and thin film surface contamination, a small subset of Genesis mission collector fragments are being subjected to extensive study via various techniques [1-5]. Here we present preliminary results for sample 60336, a Czochralski silicon (Si-CZ) based wafer from the bulk array (B/C).

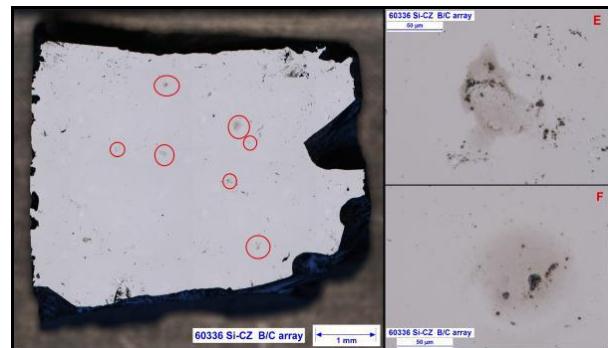
Results: Contamination appeared on the surface of 60336 after the initial 2007 UPW cleaning, presumably produced by reaction of a crash-derived contaminant with water. Figure 1 shows the sample after aqua regia and xylene treatment which did little to remove contaminants revealed by the PSI SEM examination (7/31/13). The sample was UPW cleaned for the third time and imaged (9/16/13; Fig. 2). The UPW removed the dark stains that were visible on the sample. However, some features, like “the Flounder” (a large, 100 micron feature in Fig. 3) appeared largely intact, resisting all cleaning efforts.

Fig. 1: Sample 60336 after aqua regia and hot xylene treatment (cf., 9/12/2013). The red circles indicate contamination added after the 8/6/13 imaging. Images on the right (E and F) show contamination at two different positions.

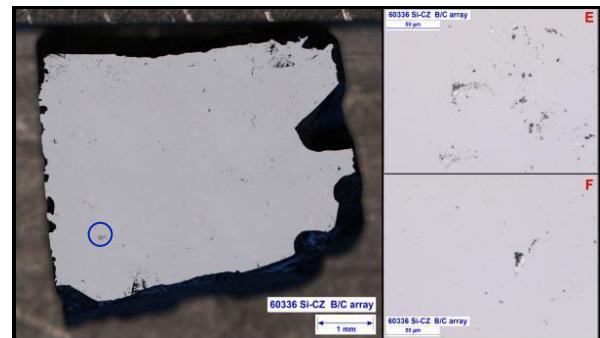
Fig. 2: Sample 60336 after UPW cleaning (9/16/13). Right: images showing the dark stains (Fig. 1) are no longer visible.

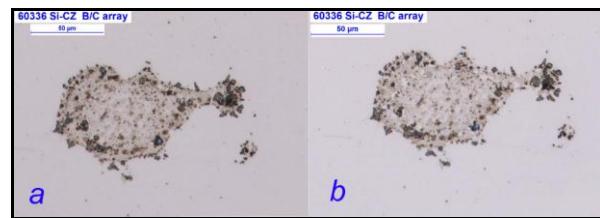
Fig. 3: Images of “the Flounder” contamination possibly added during initial UPW cleaning (Fig. 2 blue circle). (a) after SEM analysis and UPW cleaning; b) after aqua regia + hot xylene treatment, followed by UPW cleaning.

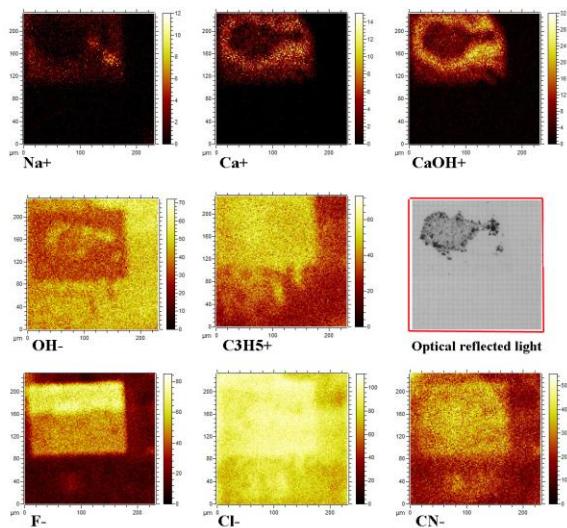
ToF-SIMS imaging has been useful of this technique for the characterization of contamination on Genesis samples [1]. Figures 4 and 5 are ToF-SIMS ion images (positive and negative) of the Flounder. The prominent square around the feature is an outline of the area scanned with high-vacuum SEM. From ToF-SIMS analysis it is clear that the SEM deposited various hydrocarbons in the scanned area. There is

also an apparent enrichment in F and Cl in the feature, as well as enrichment in Ca around it. Hydrocarbons obscured the speciation of the Ca compound; however, correlation of Ca+ and CaOH+ localizations suggest Ca oxide and/or hydroxide.

Fig. 4 ToF-SIMS images of "Flounder" before Ar sputtering.

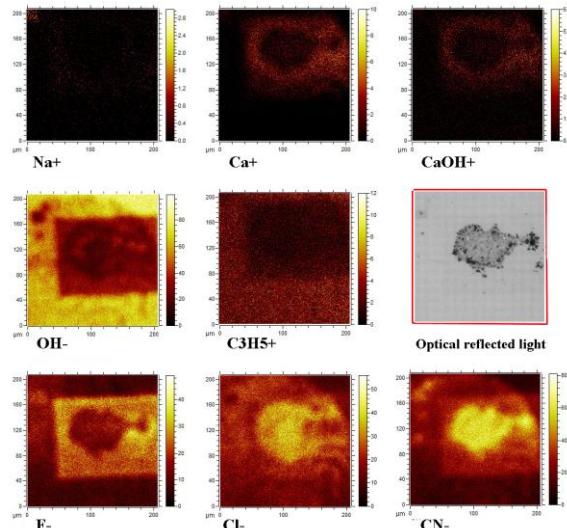
Ar sputtering (Fig. 5) removed most hydrocarbons, Na, as well as much of the Ca – suggesting that these

were likely present as a very thin surficial film.

Cl may be a compositional part of this contamination as ion images show mobilization of Cl in the areas of high-resolution SEM x-ray mapping (tail of the Flounder). Signal from CN⁻ is likely an artifact, but indicates the area of overall C-enrichment. No Ca or CaOH was detected outside of the Flounder.

Fig. 5: ToF-SIMS images of "Flounder" after Ar sputtering.

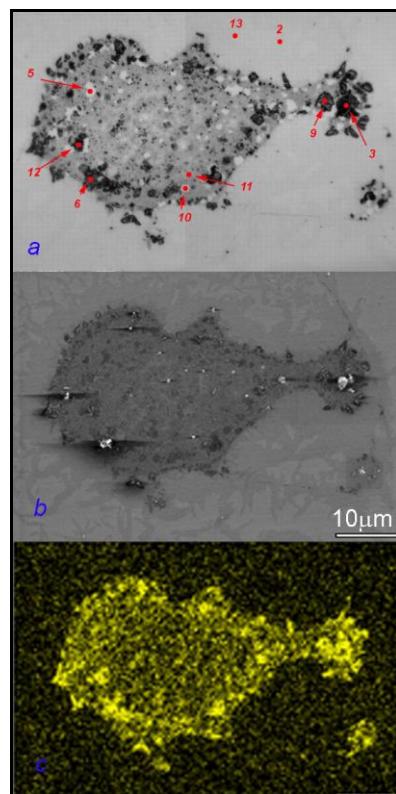
High-vacuum SEM imaging showed that there are numerous feature in the Flounder, including: (1) particles (possibly, non-conductive - charging in Fig. 6b), (2) thin films, and (3) an enrichment in C (Fig. 6c).

Low-vacuum SEM analyses of individual features within Flounder are presented in Table 1. Si values are high because the EDS excitation volume (3kV beam) is significantly larger than thickness of the contamination. Some compositional correlations with surface features can be observed: Points 2, 13 lay outside of Flounder; "white" specs (points 5, 10) have low C/O ratio, possibly Ca oxide or hydroxide; "black" specs (points 3, 9, 6, 12) have high C/O ratio, possibly Ca carbonate.

Fig. 6: a) Optical image of Flounder. b) SEM BSE (High vacuum) image. c) High-vacuum EDX X-ray map of Carbon.
