**CATASTROPHIC IMPACT OF SILICON ON SILICON: UNRAVELING THE GENESIS IMPACT USING SAMPLE 61881.** K. R. Kuhlman<sup>1</sup>, H. Kim<sup>2</sup>, A. J. G. Jurewicz<sup>3</sup>, C. P. Gonzalez<sup>4</sup>, K. K. Allums<sup>5</sup>; <sup>1</sup>Planetary Science Institute, 1700 East Fort Lowell, Suite 106, Tucson, AZ 85719; kim@psi.edu, <sup>2</sup>Microscopy and Imaging Center, Texas A&M University, 2257 TAMU, College Station, TX 77843-2257, <sup>3</sup>Arizona State University, Tempe, AZ, <sup>4</sup>Jacobs, NASA Johnson Space Center, Houston, TX 77058, USA, <sup>5</sup>HX5, LLC – Jacobs JETS Contract, NASA Johnson Space Center, Houston, TX 77058.

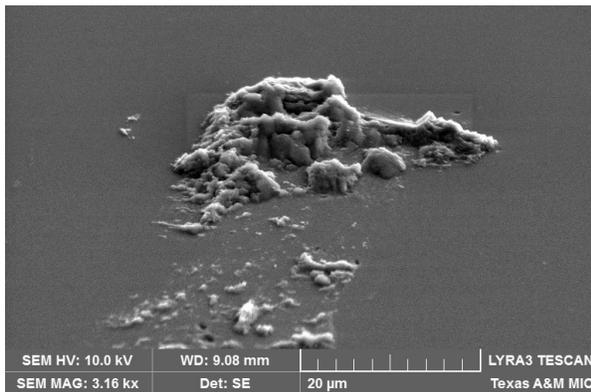
Figure 1. Silicon contamination remaining on Genesis CZ silicon sample 61881 after UPW and IPA cleaning. The sample has been tilted 55 degrees from normal in a Tescan Lyra FIB. A faint electron beam-deposited layer of Pt can be seen across the upper edge. This layer was then coated with a 2 micrometer-thick strip of ion beam-deposited Pt.

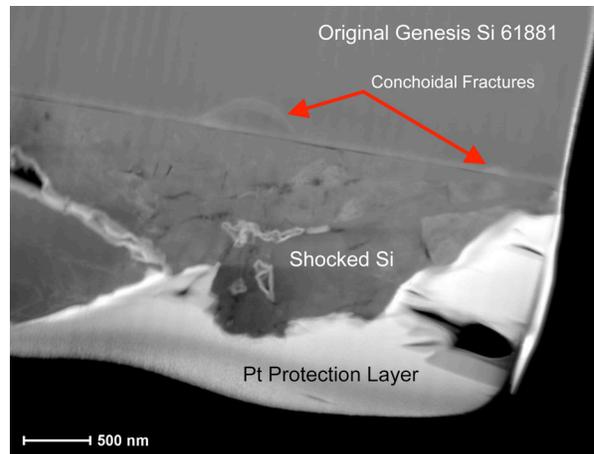
Upon sectioning, it was evident that the silicon contamination was heavily damaged. However, initial TEM observations showed that the underlying CZ silicon is undamaged, except for two small conchoidal fractures (Figure 2). Further imaging clearly showed the solar wind implanted surface of the original Genesis collector, approximately 75 nm deep (Figure 3). We also observed a heavily shocked layer of silicon that is partially amorphous and partially polycrystalline with varying crystal orientations as shown by diffraction (Figure 3). A very distinct layer was seen at the interface between the original collector and the silicon contamination. This layer appears to vary gradually in thickness up to 10 nm, thicker than expected for the native SiO<sub>2</sub> on Genesis flight silicon [5]. In some places, this layer seems to disappear completely. We investigated the interface further using an EDS line scan beginning in an area of shocked polycrystalline silicon and ending at the edge of the solar wind implanted layer (Figure 3). The oxygen profile is shown as an overlay in Figure 3. This profile appears to be elevated in the interfacial layer as well as in the top 5 nm of the collector. Other than a small signal from the copper grid, no other elements were observed. It may be that the native SiO<sub>2</sub> layer on the collector is imaging as brightly as the silicon because it has been subject to solar wind irradiation damage.

Figure 2. Dark field TEM image of finished silicon on silicon sample extracted from Genesis sample 61881 using a FIB. Note the conchoidal fractures at the surface of the silicon collector material.

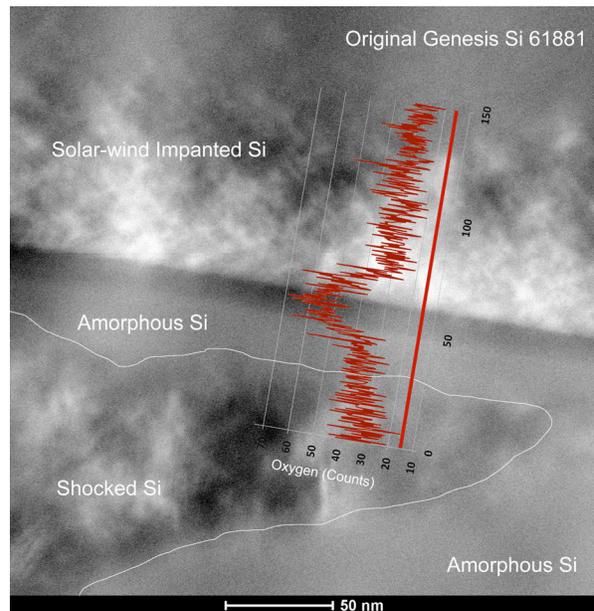
Figure 3. HAADF STEM image of the interface between the silicon contamination in Figure 1 and the Genesis silicon collector material. The line profile is the EDS measurement of oxygen (counts). Note the elevated oxygen in what appears to be the collector silicon.
