REPORT ON THE LOSS OF VIKRAM LANDER OF CHANDRAYAAN 2 MISSION

Malaya Kumar Biswal M¹, Ramesh Naidu Annavarapu²

Department of Physics, Pondicherry University, Puducherry – 605 014, India.

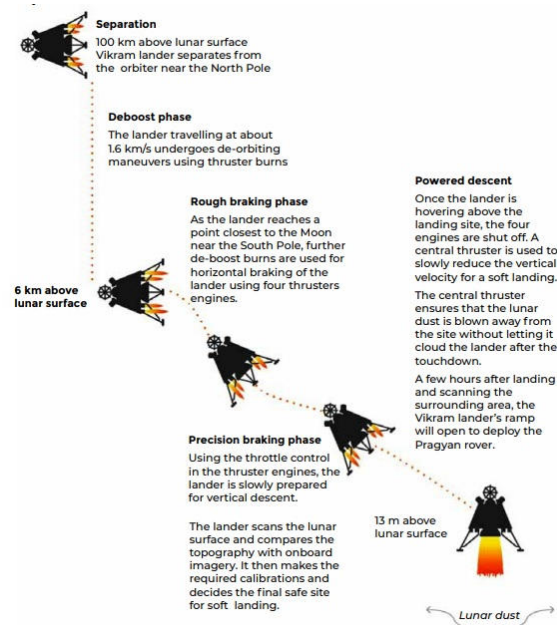
Figure 1 Vikram Lander Sequence (Credit: ISRO)

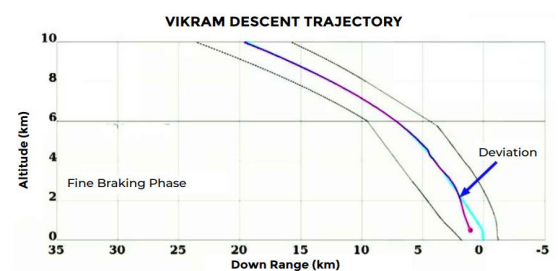
Trajectory Deviation: From the trajectory map of Vikram lander operation, we can see that the lander trajectory path was normal up to 2.2 km, but at an altitude of 2.1 km the lander’s trajectory got deviated from usual path resulting in the loss of communication

and uncertain mission status. Observed trajectory deviation is from 2.1-0.2 km above the lunar surface. The deviated trajectory path from 0.2-2.1 km is shown in Figure 2.

Figure 2 Vikram Lander Trajectory (Credit: ISRO)

- During the course of rough braking phase and powered descent phase, the vibrations aroused may have misplaced or unplugged the power cord of the communication system (or antenna) resulting in the loss of communication from the ground.
- At the point of deviation shown in the trajectory graph, the shutdown of thrusters or improper firing of descent thrusters

might have caused the spacecraft to lose control over spacecraft orientation resulting in the crash of lander on to the surface.
