RUST CONTAMINATION FROM WATER LEAKS IN THE COSMIC DUST LAB AND LUNAR AND METEORITE THIN SECTION LABS AT JOHNSON SPACE CENTER. J. J. Kent^{1,2}, E. L. Berger^{1,2}, M. D. Fries², R. Bastien^{2,3}, F. M. McCubbin², L. Pace², K. Righter², B. Sutter^{2,3}, R. A. Zeigler², M. Zolensky² ¹GeoControl Systems Inc., Jacobs JETS Contract, NASA Johnson Space Center, Mail Code XI2, Houston, TX 77058. ²NASA Johnson Space Center, Mail Code XI2, Houston, TX 77058 ³Jacobs, Houston, TX jeremy.j.kent@nasa.gov

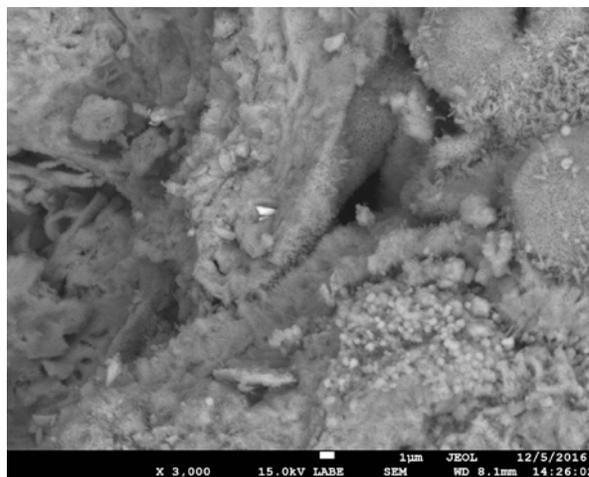
SEM. Observations and EDX spectra obtained on the SEM further confirm the Raman and XRD findings (Figs. 2 and 3). Cosmic Dust Lab materials are almost exclusively limited to iron oxides, whereas Sample Preparation Lab material contains a wider variety of detritus.

Figure 2: BSE image of rust particles from the Cosmic Dust Lab

At the beginning of 2016, a separate leak occurred in the Cosmic Dust Lab, located in the same building. In that lab, a water leak occurred at the bottom of the sink used to clean the lab's tools and containers with ultra-pure water. Over years of use, the ultra-pure water eroded the metal sink piping and leaked water onto the inside of the lab's flow bench. This water also left behind a film of rusty material. The material was cleaned up and the metal piping was replaced with PVC pipe and sealed with Teflon plumber's tape.
