BREACHED CRATERS ON MARS: TERRESTRIAL ANALOG OF DOWNSTREAM EROSION

CANYON LAKE GORGE

R. A. DE HON, TEXAS STATE UNIVERSITY

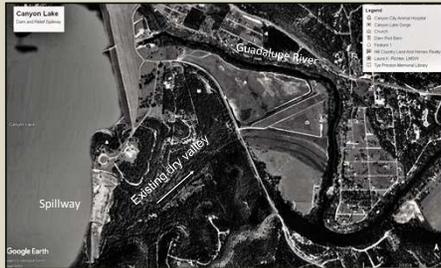
Outflow from the Canyon Lake Reservoir in 2002 in response to heavy rainfall in the watershed provides an analog to downstream channels cut by spillover from flooded craters on Mars.

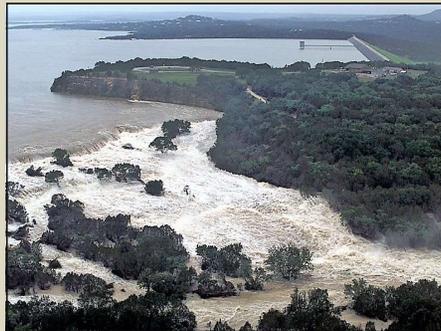
A 365 m wide spillway was cut and re-enforced to relieve overflowing of the lake above the 277m level. The storage capacity of the lake at conservation level is 471,000,000 m³. Normal flow exits the lake through tunnels below the dam and continues down the existing Guadalupe River channel. Overflow discharged through the spillway rejoins with the Guadalupe 2.5 km west of the dam. A paved road crossing the relief channel was built to washout in the event of flooding.

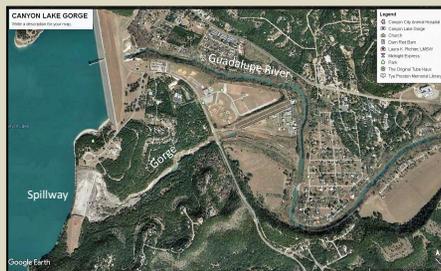
Outflow at Canyon Lake relief spillway during 2002 flood crested 2.3 m above the spillway as 2.5 times the volume of the lake was discharged over a 7 day period. Extensive flooding occurred downstream.

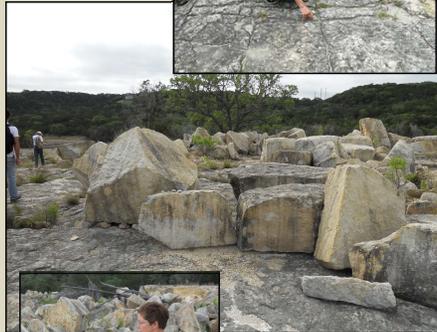
The discharge removed vegetation; a thin regolith; and 650,000m³ Cretaceous limestone to create a bedrock gorge. Most incision occurred within the first days of the outflow.

Bedding planes and jointing in limestone controlled quarrying of blocks of limestone 1-1.5 m on a side. Blocks, which moved short distances, retained flat sides and angular edges.

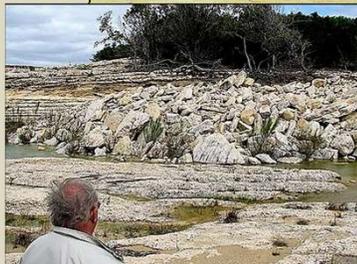
A thin cover soil and blocky regolith was stripped from the limestone bedrock. Angular limestone boulders were moved short downstream by turbulent flow. Residents of the area report hearing blocks tumbling above the roar of the flood flow. The longitudinal profile is typical nongraded with many small falls and large pools.

A much reduced flow is seen here a week after the initial overflow. Bedding planes control the stepped topography. Photograph by Paul N. Smith

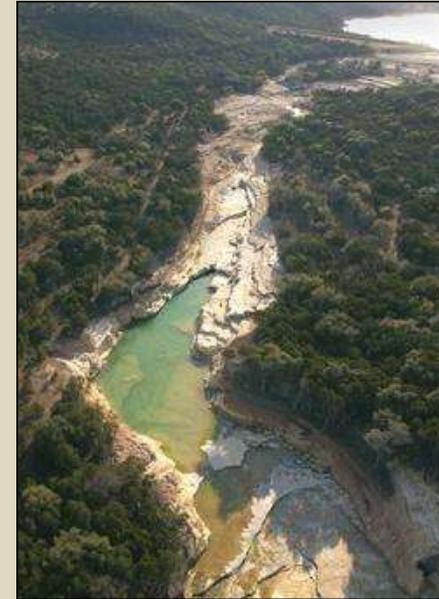
Erosion by the overflow created a bedrock channel in solid limestone. Limited depositional features are seen as a mega-point bar deposit of 1-1.5 m imbricate blocks in the upper part of the gorge; a mid-channel bar with similar boulders; and the dumping of 230,000 m³ rock and soil at the confluence with the Guadalupe River and the overflow channel.

The channel floor is mostly solid rock which descends in steps controlled by bedding planes in the bedrock. The irregular floor has many large, deep pools. Photograph by David Ferrill, Southwest Research Institute.

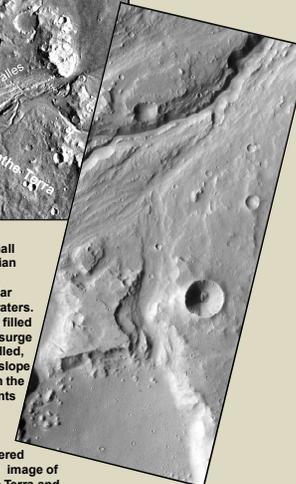
Many craters were flooded in the Xanthe Terra region in response to the initial Maja outflow.

The Canyon Lake spill is small compared to the major Martian catastrophic outflows, but it provides an analog for similar discharges from beached craters. This 25 km diam. crater was filled to overflowing by the initial surge of the Maja outflow. Once filled, water spilled over the downslope rim and cut a channel to join the main Maja channel. Remnants of two smaller craters are dissected by the gorge, and steps in the channel walls suggest the presence of layered resistant bedrock. Mariner 9 image of Maja Valles crossing Xanthe Terra and HiRISE image of breached crater.
