A RECORD JÖKULHLAUP FROM THE SUBGLACIAL LAKE BENEATH THE EASTERN SKAFTÁ CAULDRON, VATNAJÖKULL ICE CAP, ICELAND

¹T. Jóhannesson, ¹B. Einarsson, ¹B. Ófeigsson, ¹M.J. Roberts, ¹O. Sigurðsson, ¹K. Vogfjörð and ¹Th. Thorsteinsson

¹Icelandic Meteorological Office, Bústaðavegi 9, IS-108 Reykjavík, Iceland. E-mail: tj@vedur.is

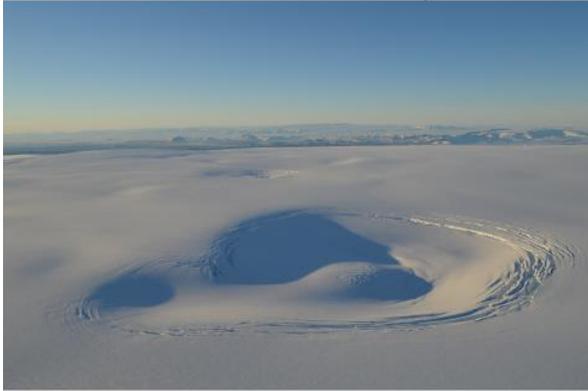
Fig. 2. View of the surface cauldron after the jökulhlaup in October 2015.

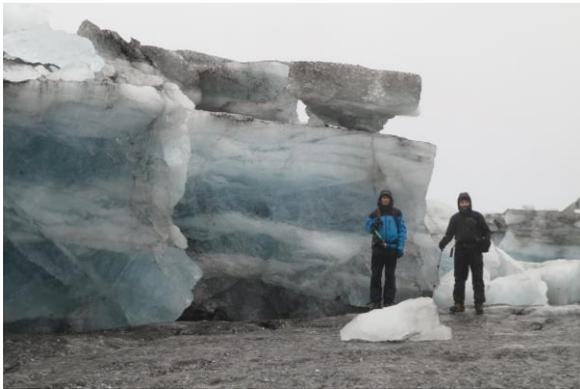
Fig. 3. Ice blocks on the surface close to the place where the floodwater burst through the ice.

mented from the flood waters extended down the terminus where the *jökulhlaup* had flowed. Ice fragments were scattered over the surface of the glacier, a few tens of cm in size near the terminus but blocks up to 3–5 m high and 10 m long were observed close to the outflow points where the water had burst through the ice. The flood waters appeared to have flowed through the glacier for some time and concentrated in one or more circular channels that the flow melted through the glacier. The flow up through the glacier did not last long, though, and a few hours after the initial outburst, the *jökulhlaup* flowed out through six or seven main outlets at the terminus. The outburst of this *jökulhlaup* in Skaftá through the terminus area of Skaftárjökull glacier appears in many ways similar to the start of the much larger *jökulhlaup* from Grímsvötn through Skeiðarárjökull in S-Vatnajökull in 1996 except that the breakup of the ice in 1996 was much more dramatic and the ice blocks correspondingly larger. The subsidence of the ice shelf in the cauldron was monitored in real-time with a networked GPS-instrument allowing a several day warning of the impending flood. Other instruments and measurement systems, including two GPS-instruments on the glacier over the flood path 15 and 3 km from the terminus, seismic stations on the glacier and near the glacier margin, seismic arrays close by the glacier, and hydrometric stations in Skaftá river, provide an unprecedented data set documenting the developments of this flood, both as it propagated subglacially along the glacier bed and also after it entered the river path and continued into the lowland as a subaerial flood. The propagation mechanism of this *jökulhlaup*, its effects in lowland areas and the potential hazards of similar sized floods in the future are currently being assessed by the Icelandic Meteorological Office and other bodies.

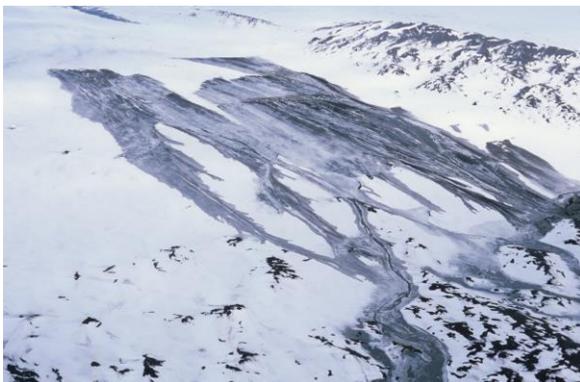
Fig. 4. Debris flows on the ice surface due to floodwaters emerging from below. Photo from a 2006 jökulhlaup at the same site.
